STRUCTURAL ASSESSMENT OF AN OLD BUILDING

'Jivdani Apartment' is a residential society located at LBS Marg, Thane, Mumbai. The structure was constructed approx. in the year 1982. In view to know the present structural condition of the structure & the concrete, the society appointed M/s EPICONS CONSULTANTS PVT. LTD. to carry out the Structural Assessment of the society building. In order to check the in-situ strength & quality of the RCC elements, the Non Destructive testing was planned. Accordingly, the field work was carried. Condition survey was carried out during this period between 17th December 2016 to 25th December 2016 & Non Destructive testing was scheduled between 7 January 2017 to 11th January 2017.

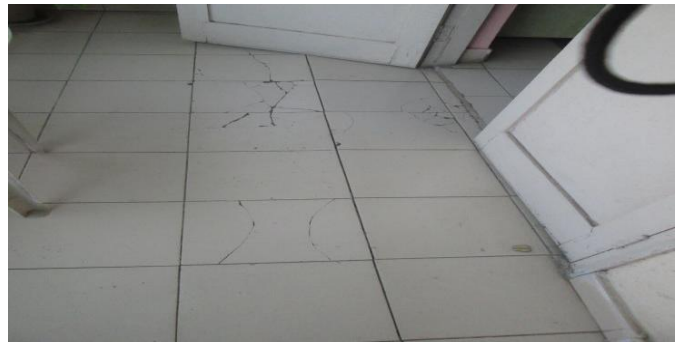
Fig 3: Uplift of tiles due to corrosion

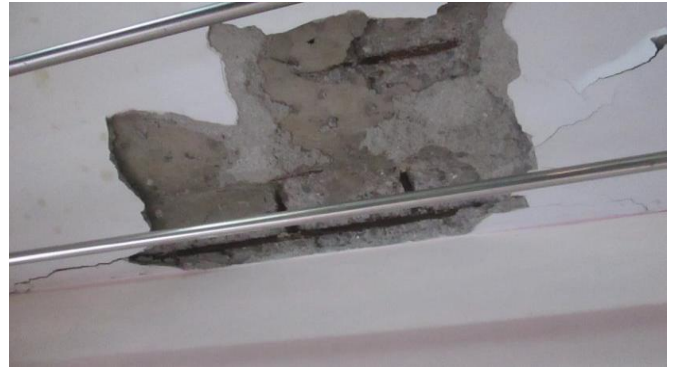
Fig 4: Corrosion seen in slab.

- I. All the structural elements identified with corrosion related distresses shall be attended by carrying out patchwork repairs in the form of following step by step procedure:-

- a) Removing loose concrete with well-defined edges.
 - b) Thoroughly cleaning the reinforcement & augmenting the same if required.
 - c) Applying passivator coat to reinforcement.

- d) Applying bond coat to concrete surface.
 - e) Application of single pack polymer modified mortar (PMM) from reputed manufacturer.
 - f) Some of the key areas where such patchwork repairs are to be carried out include stilt level beams at few internal columns & beams inside the flat, beams in car parking areas etc.

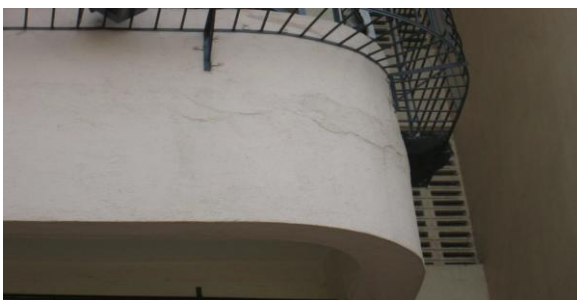
Fig 1: Cracks seen on pardi.

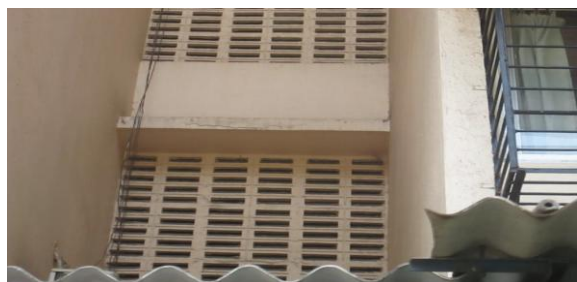
Fig 2: Cracks seen on chajja.

- h) External chajjas have severe corrosion cracks, patchwork repairs of these thin members is not advisable as it is neither effective nor cost effective. Hence, it is strongly recommended to demolish the existing chajjas & re-construct the same using better quality concrete.

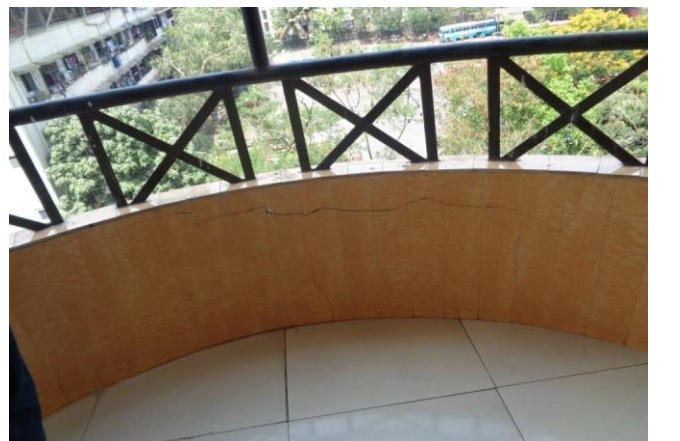
Fig 6: Cracks on balcony Parapet walls.
